**DAM SAFETY INSPECTION  
REPORT**

**DAN RIVER STEAM STATION  
ROCKINGHAM COUNTY,  
NORTH CAROLINA**

**PAUL C. RIZZO ASSOCIATES, INC.  
101 WESTPARK BOULEVARD, SUITE B  
COLUMBIA, SOUTH CAROLINA USA 29210**

**PROJECT NO. 09-4157  
JULY 2009**

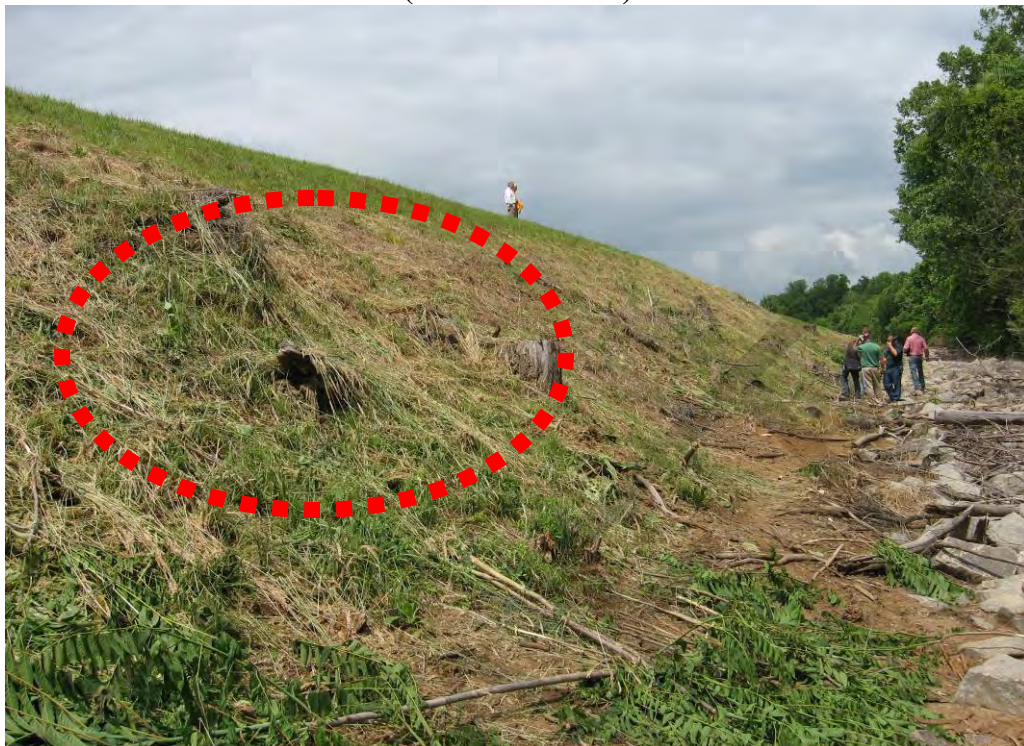
**PHOTO 5: STUMPS IN PRIMARY POND SOUTHERN EMBANKMENT SLOPE  
(LOOKING NE)**

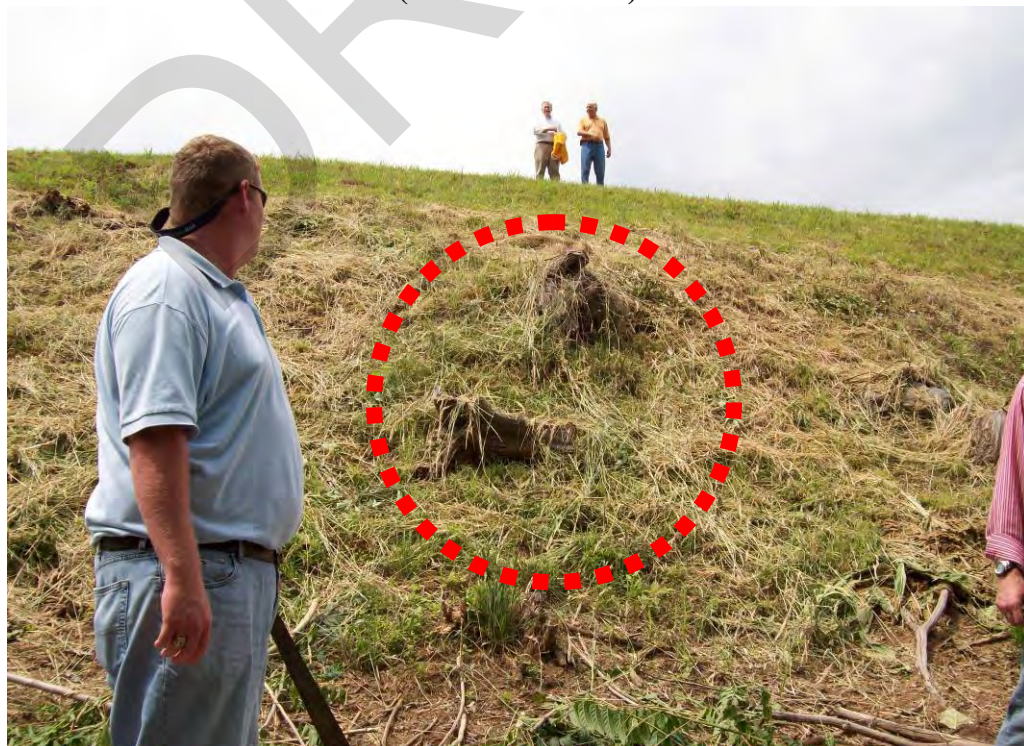
**PHOTO 6: STUMPS IN PRIMARY POND SOUTHERN EMBANKMENT SLOPE  
(LOOKING NW)**

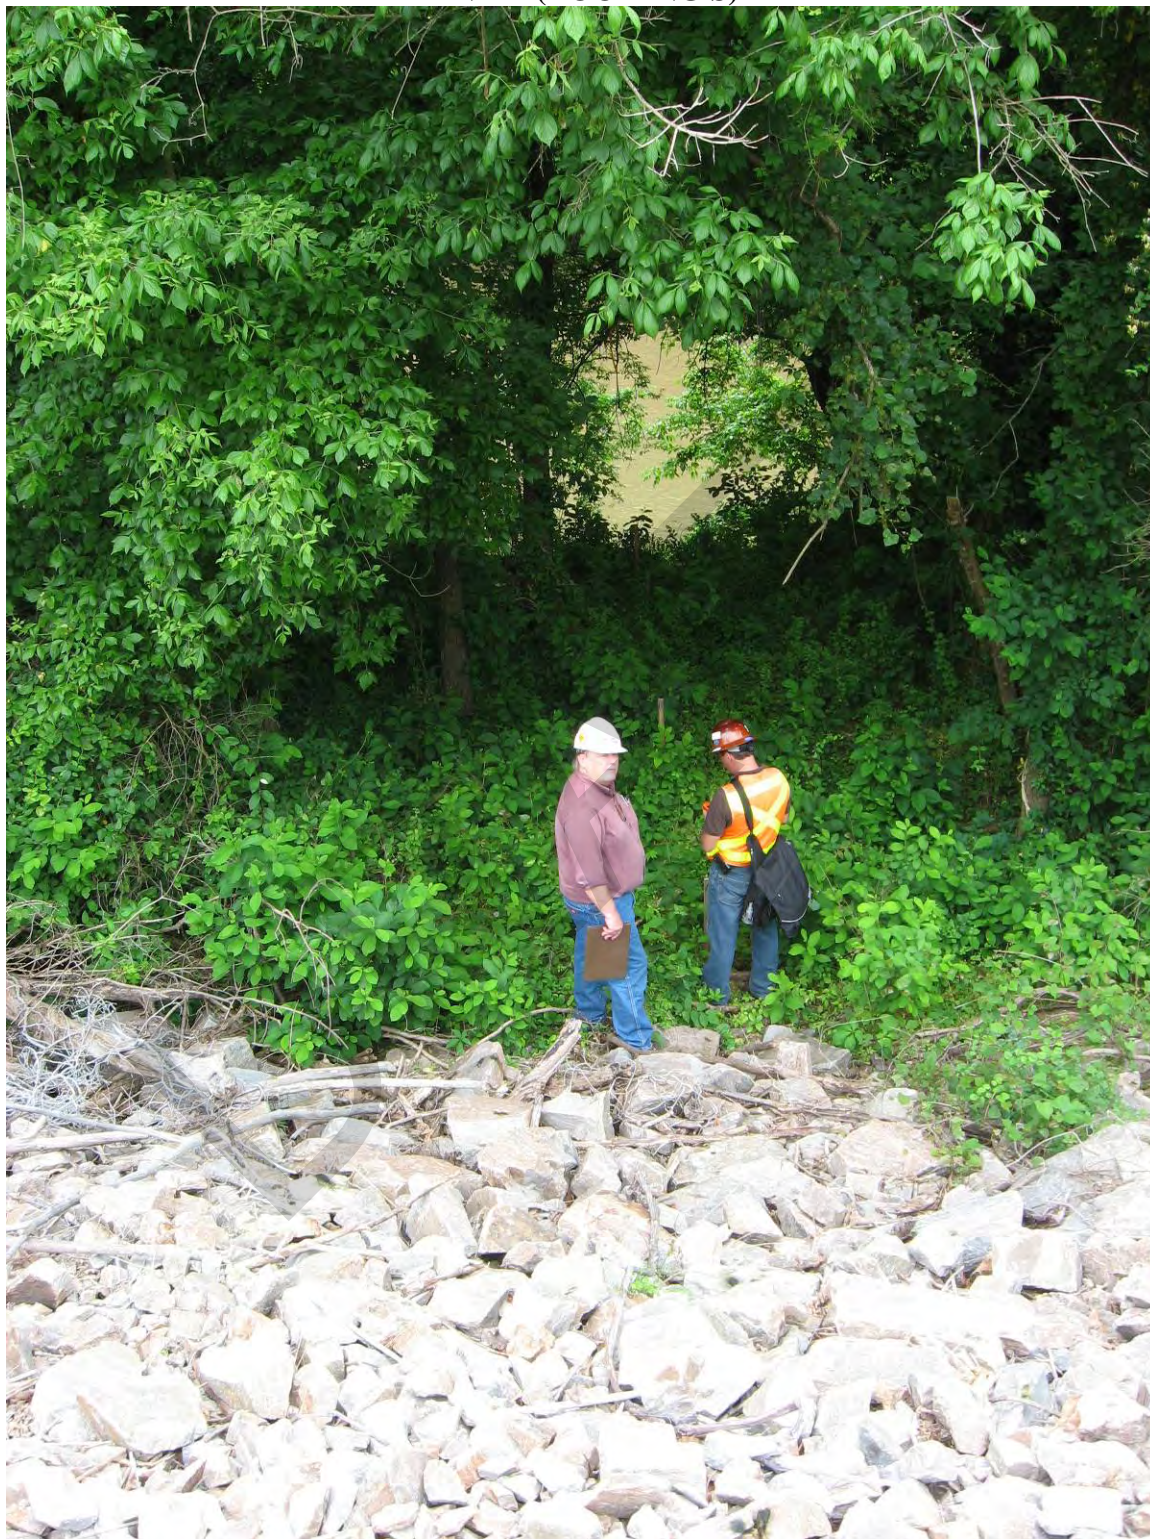
The survey monuments set up between the river bank and the embankment were noted. The monuments have been staked for easy identification and consist of steel pins driven into the ground. The monitoring system recommended by the previous consultant appears to have been installed as requested.

**PHOTO 8: SURVEY MONUMENT SECTION PERPENDICULAR TO DAN RIVER (LOOKING S)**

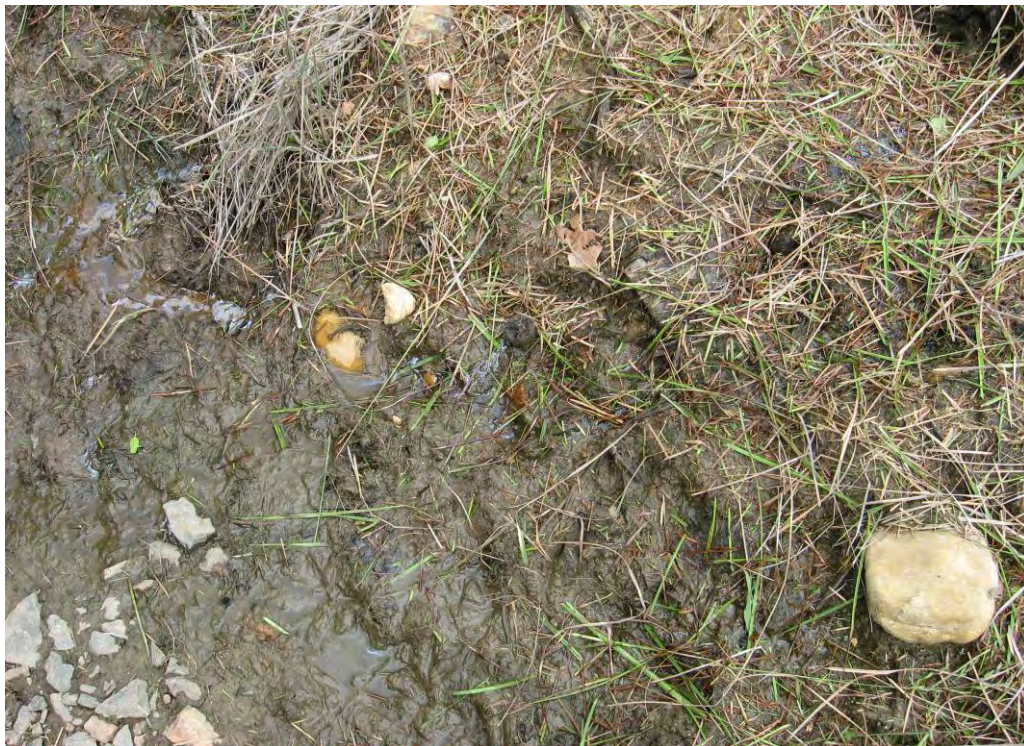
**PHOTO 9: SEEPAGE AND SATURATED AREA AT TOE OF PRIMARY POND  
SOUTHERN EMBANKMENT**

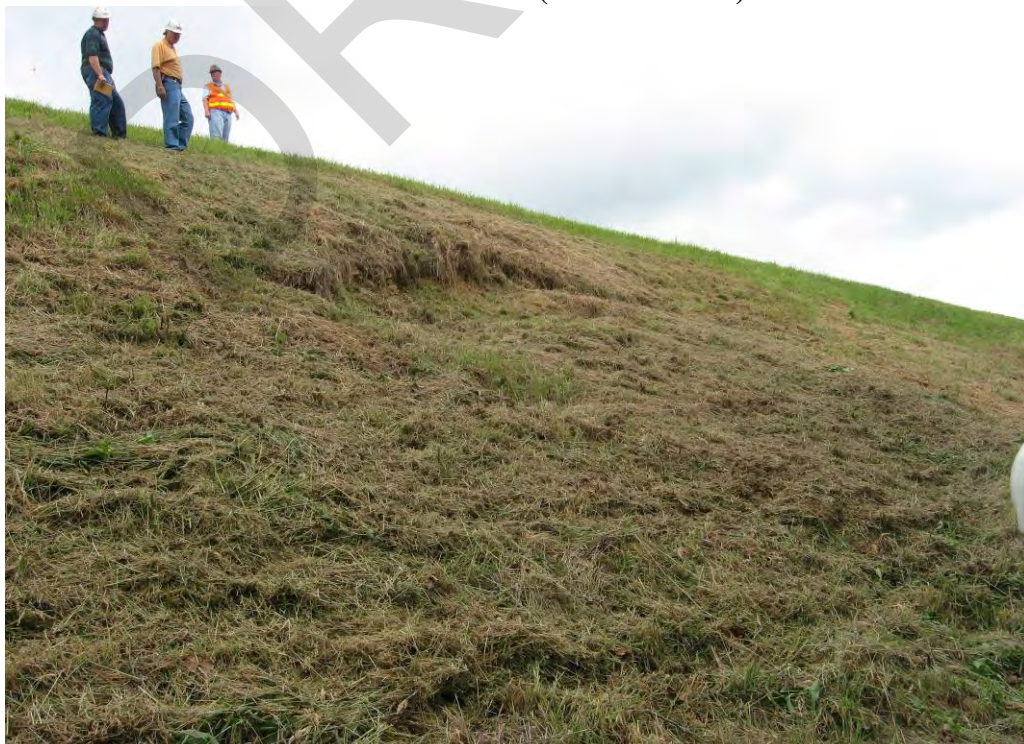
**PHOTO 10: SURFICIAL SLOUGH OF PRIMARY POND SOUTHERN  
EMBANKMENT (LOOKING N)**

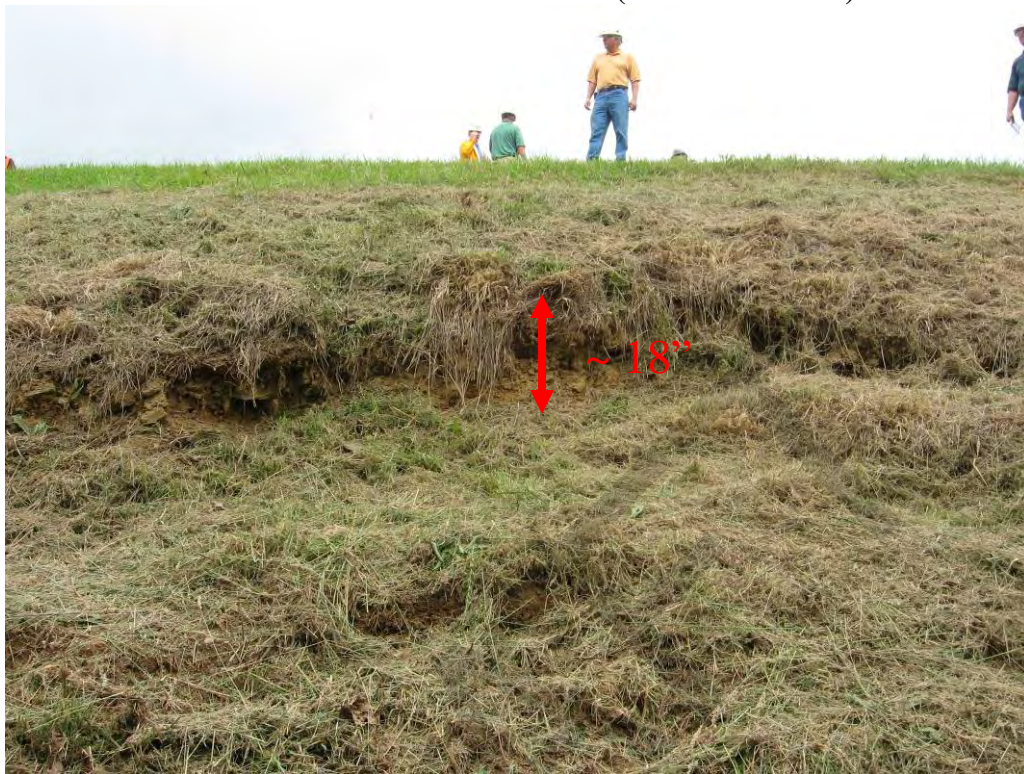
**PHOTO 11: SCARP OF SURFICIAL SLOUGH OF PRIMARY POND  
SOUTHERN EMBANKMENT (LOOKING NW)**

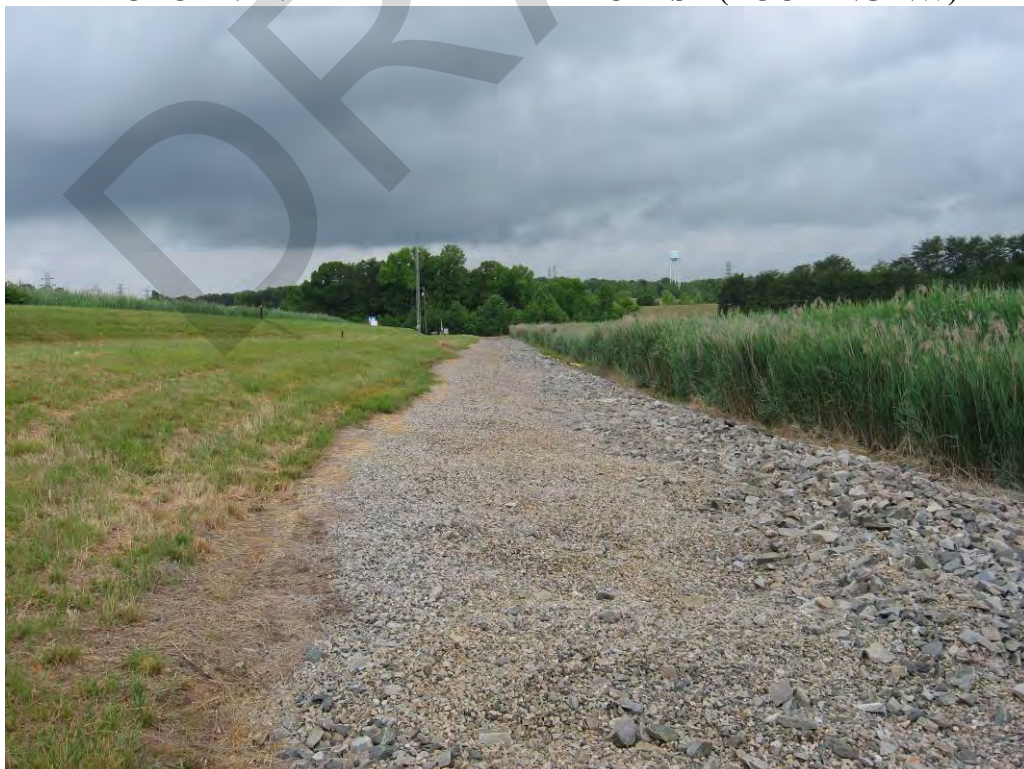
The intermediate dike dividing the Primary and Secondary Ponds appeared to be well maintained and in good condition, with a crushed gravel road across its crest and recently mowed slopes on the Primary Pond side (See Photo 12).

**PHOTO 12: INTERMEDIATE DIKE CREST (LOOKING NW)**

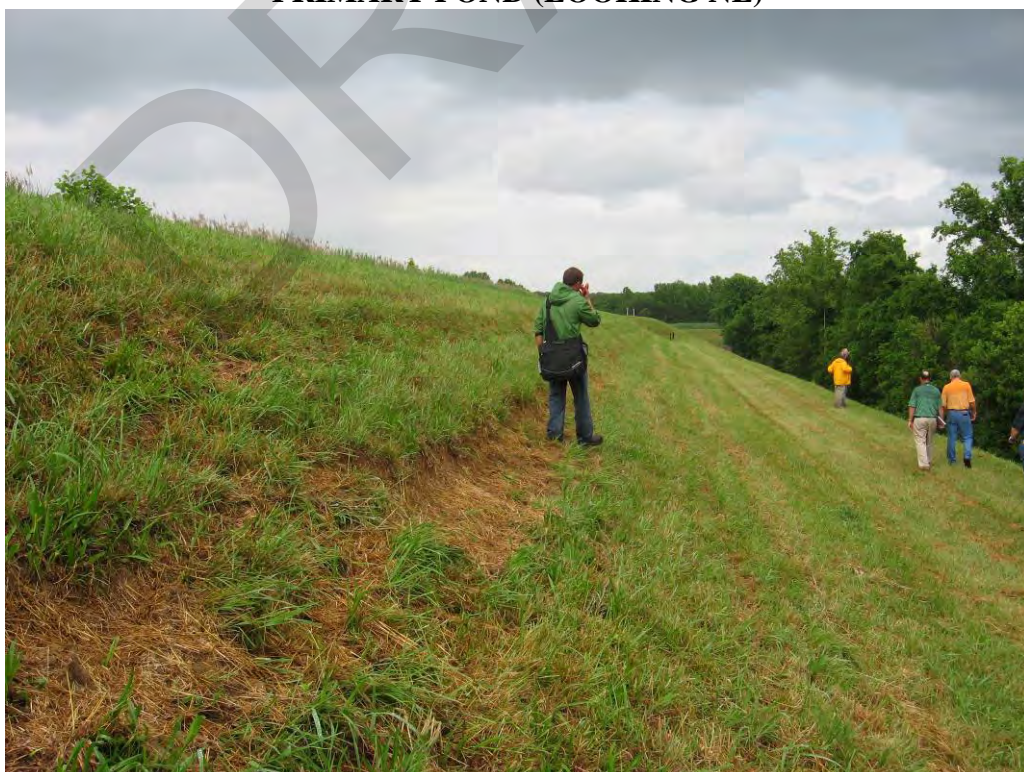
Overall, the Primary Pond embankment was found to have a good grass cover and with the exception of the southern (river) side to have smooth, even grades free of stumps, trees, brush or other deleterious vegetation. At the southwest corner of the embankment, several decaying tree stumps were found in the embankment toe and slope near the toe (see Photo 5 and Photo 6 in Appendix A). These stumps could present a hazard to slope stability, as well as potential seepage pipes as they decay. The rip rap toe berm and slope protection provided at the base of the southern embankment was generally in good condition and free of vegetation. The crest of the embankment and the elevation 525 bench appeared to be well graded and stable, with no signs of settlement noted at the time of inspection. Limited to no seepage or slope disturbance was noted along the southern embankment until approximately 1,200 feet southwest of the intermediate dike on the southern embankment. From this location to just past the intermediate dike, numerous small seeps (see Photo 9) were noted along the toe and up slope of the embankment. In addition, a wide, apparently active shallow surface slide was encountered around 800 feet west of the intermediate dike (see Photo 10 and 11). This failure surface has been noted in previous inspection reports and along with two other sections of increased seepage noted by the previous Independent Consultant are the subjects of recently installed additional instrumentation and study. At several locations along the Primary Pond embankment, shallow ruts and wallows caused by mowing equipment were noted (See Photo 14).

**PHOTO 14: RUTTING NEAR CREST OF SOUTHERN EMBANKMENT OF PRIMARY POND (LOOKING NE)**

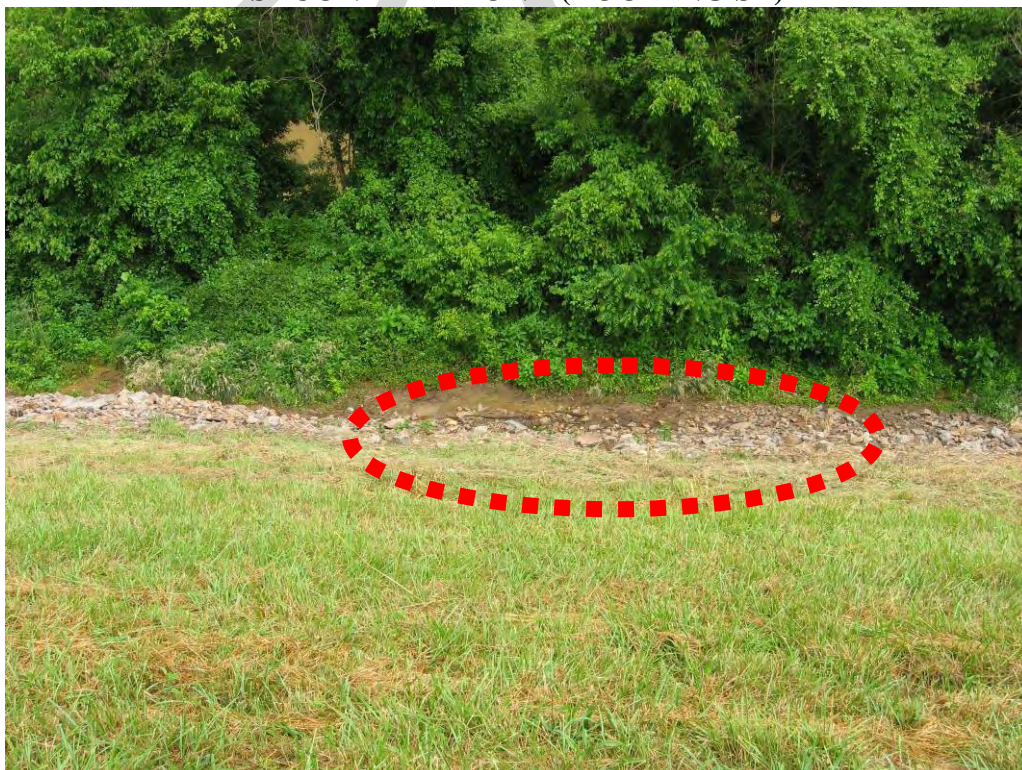
**PHOTO 16: WET AREA AT TOE OF SOUTHERN EMBANKMENT OF SECONDARY POND (LOOKING SE)**

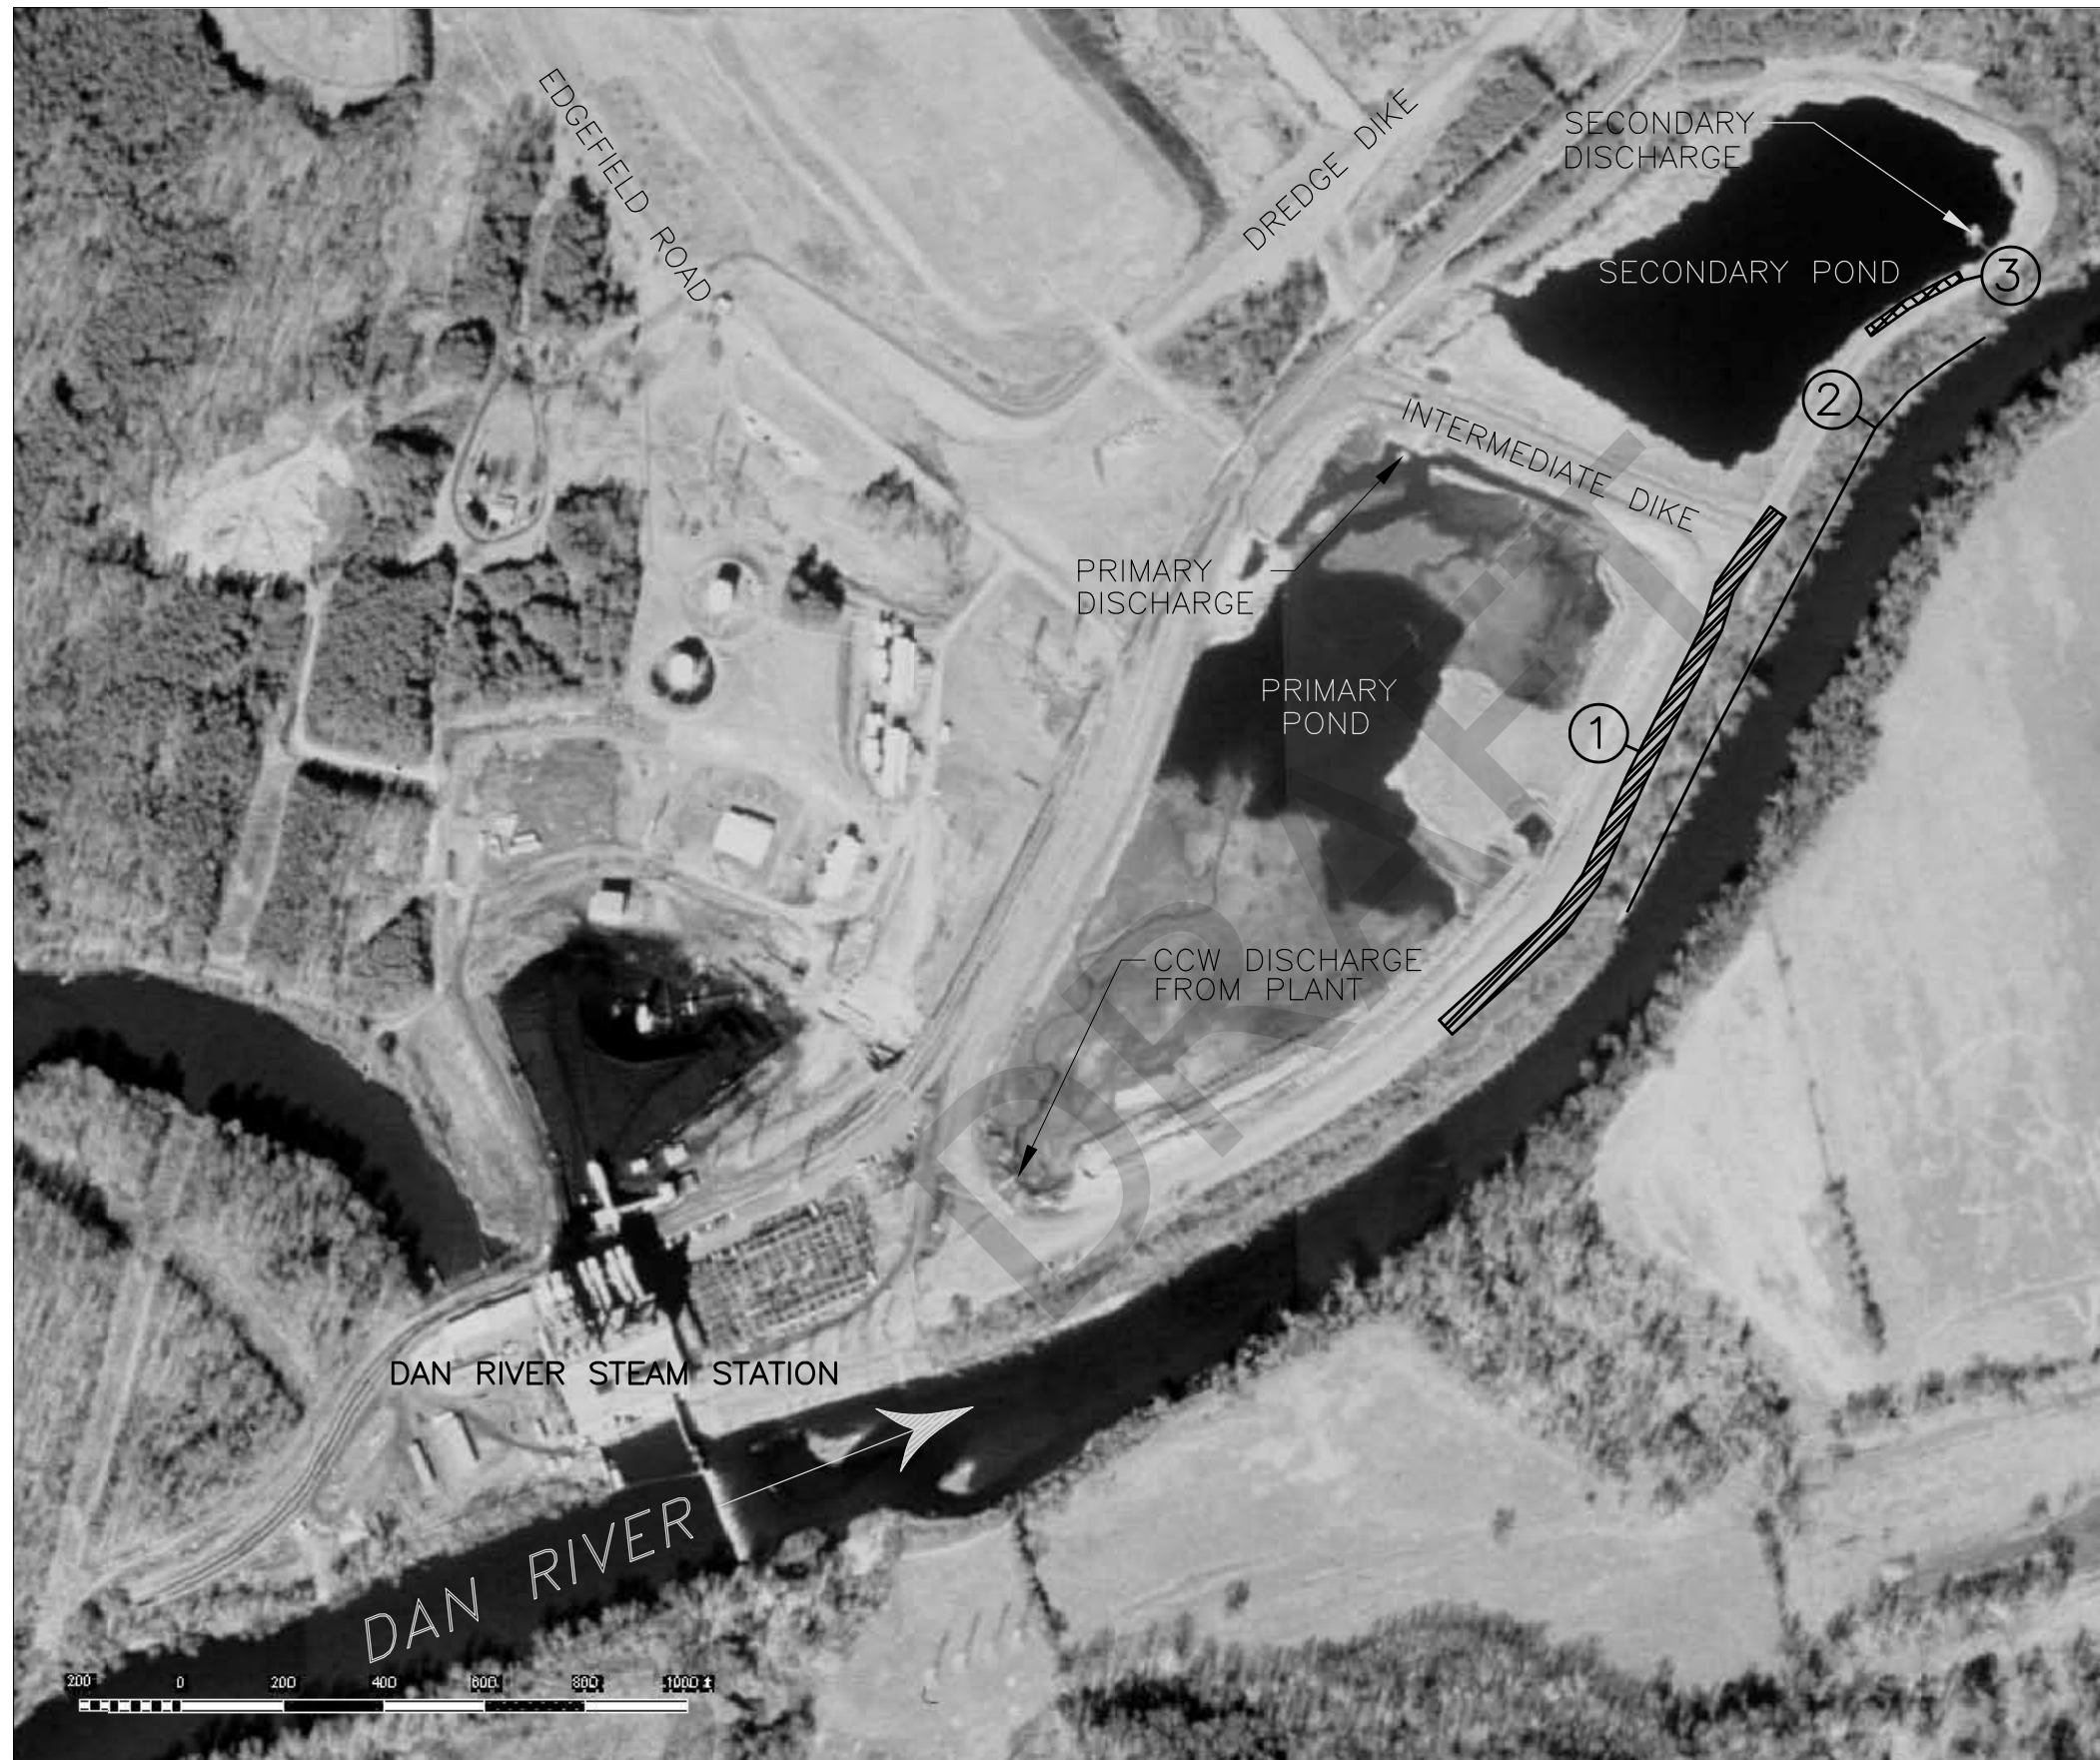
- ① SEEPAGE ZONE ALONG SOUTHERN EMBANKMENT. NUMEROUS SURFICIAL SLIDES AND LOW VOLUME SEEPAGE.
- ② ZONE OF RIVER BANK EROSION. MONUMENTS IN PLACE ALONG RIVERBANK TO MONITOR LOSS OF MATERIAL.
- ③ ANIMAL BURROWS NOTED DURING INSPECTION.

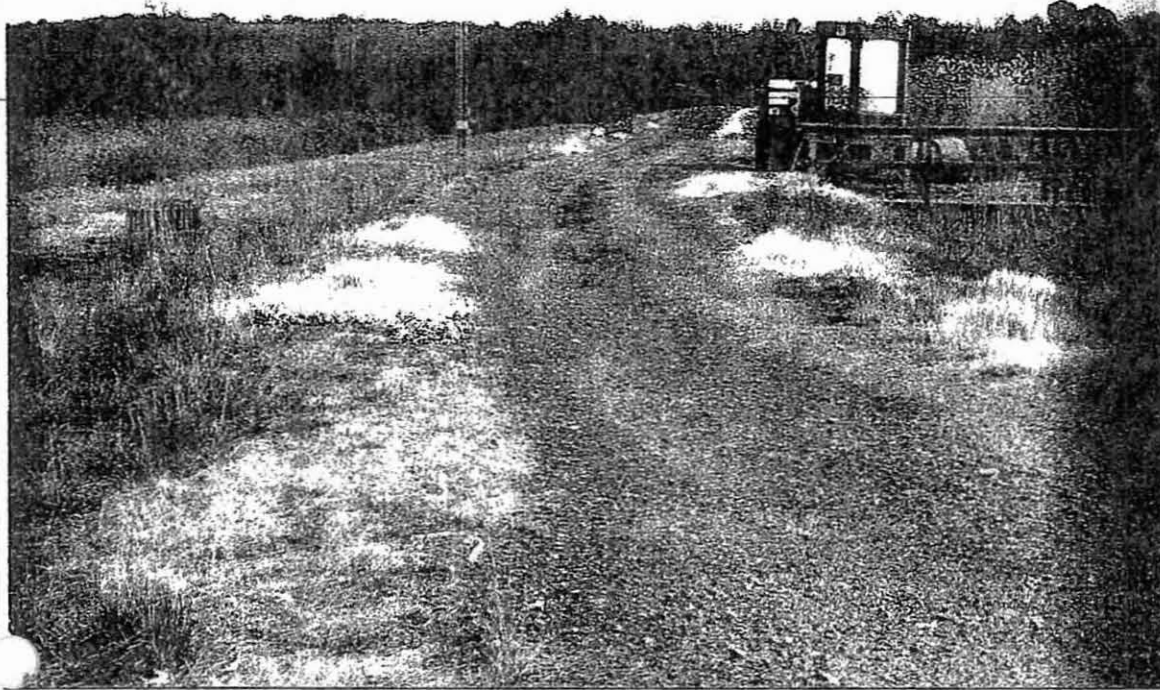
**Photograph 1**

Intermediate dike S-SE view.  
Note minor depression (no ponding) in wheel tracks seen beyond walkway to discharge tower. Metal tower constructed since 2001.

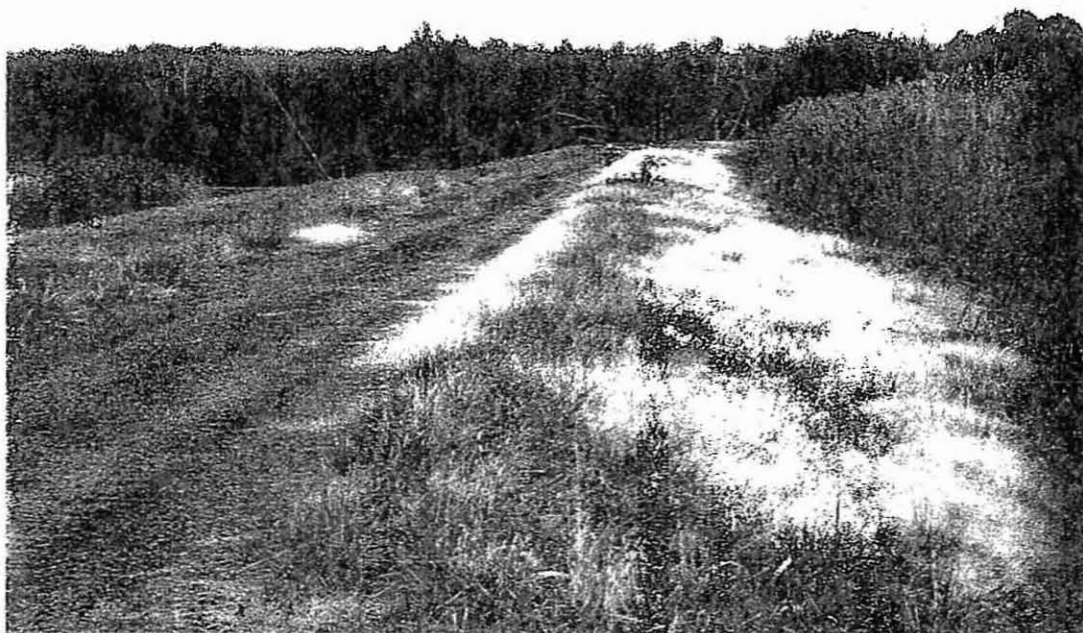
**Photograph 2**

Upstream slope of intermediate dike S-SE view. Steep slope begins about 6 ft below crest elevation. Some depressions in wheel tracks.

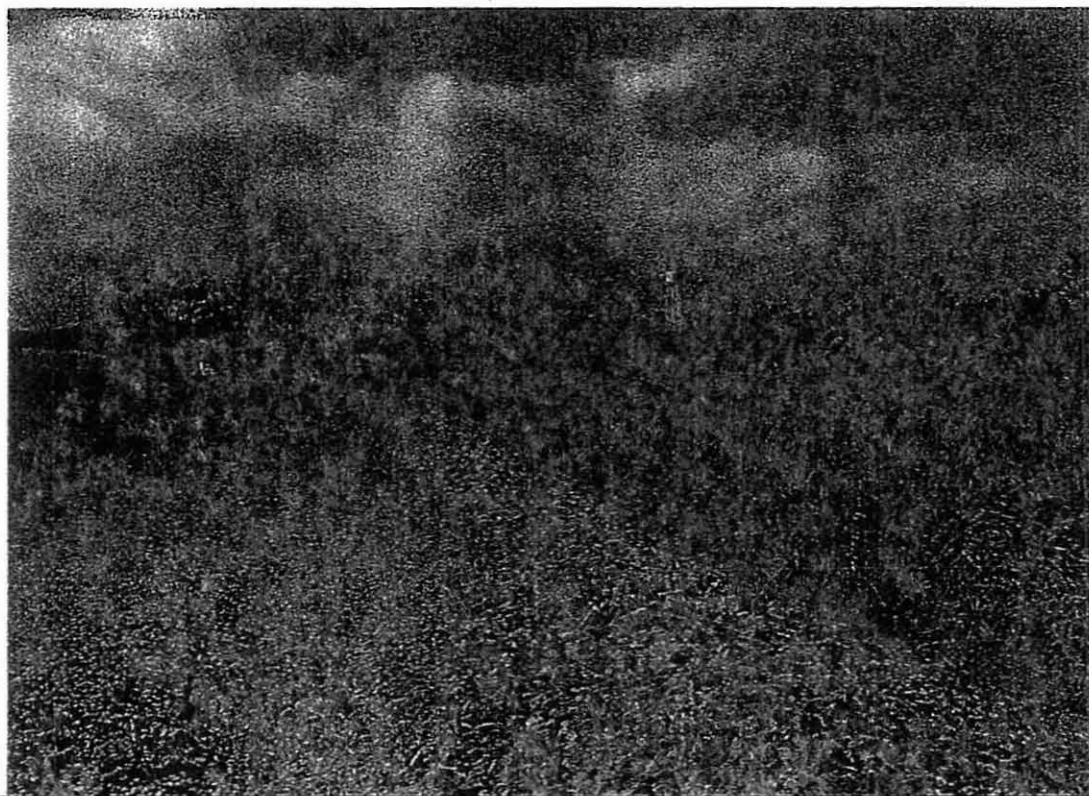
**Photograph 4**

Downstream slope of intermediate dike rock fill berm N-NW view. Small bushes beginning to grow in rock fill in 2001 have been removed.

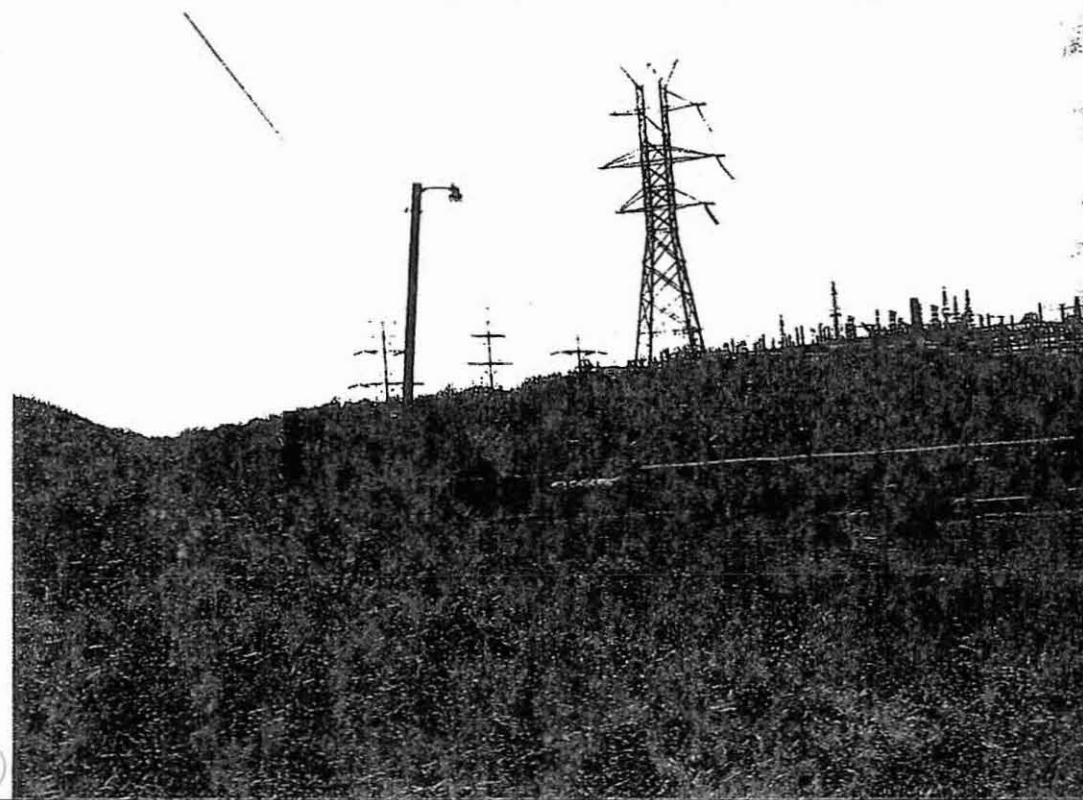
**Photograph 9**

Downstream slope of northern embankment with Piezometers 6 and 7 in background. Pole 77 closest to Photographer. Poles lean in same direction as in 2001. Poles loose in embankment. Road ditch (outside chain link fence in left side of Photograph) is wet with ponded seepage, consistent with high phreatic line in P-6 and P-7. A minor wet pothole on the crest road was observed near P-6.

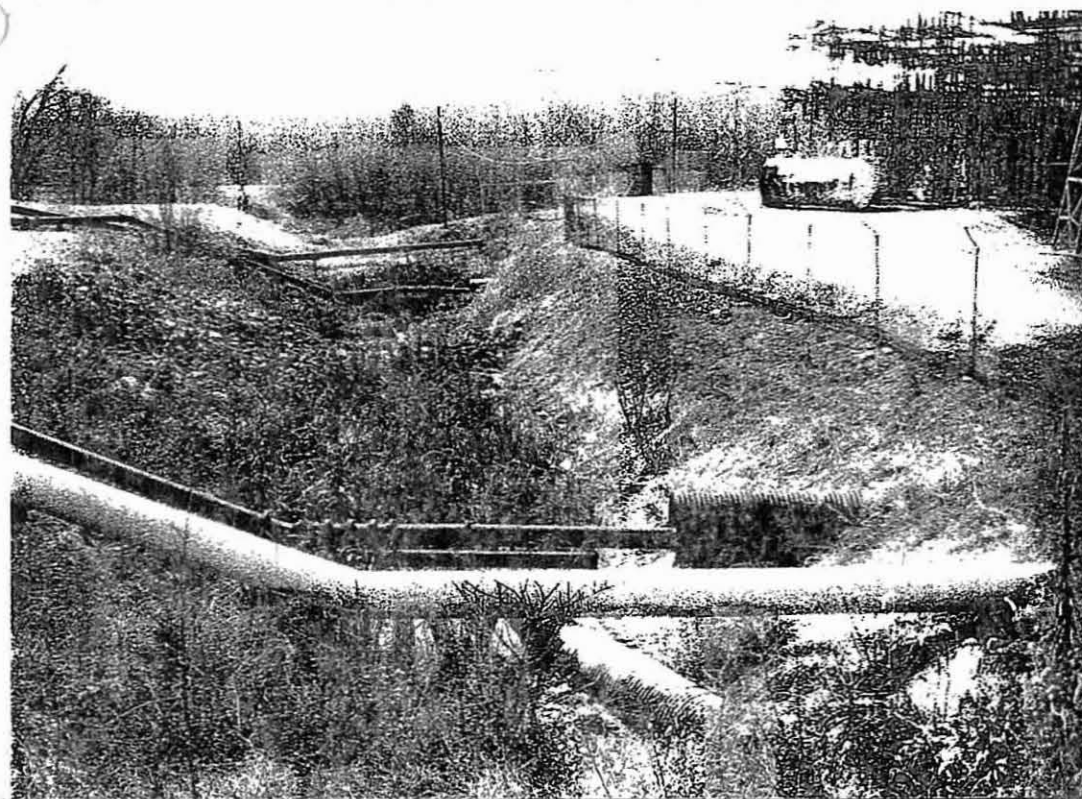
Photograph 12

Sluice pipes, facing south. Groundhog burrow observed on slope, left side, beyond rock fill.

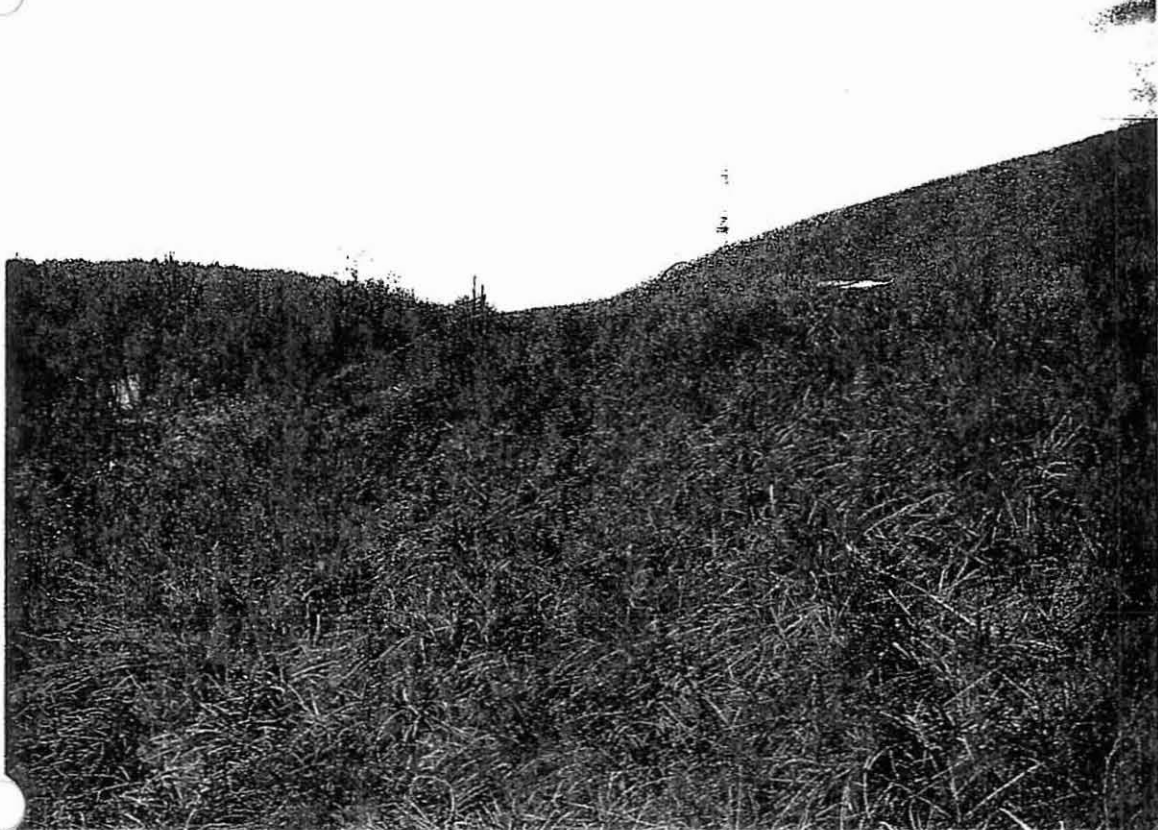
A black and white photograph of a grassy slope. The slope appears to have a slump or erosion area, with some vegetation missing or displaced. The background shows a flat area with some distant structures.	<p><b>Photograph 19A</b></p> <p>Slump in slope below elevation 525 berm looking S-SW. Slump has moved since 2001.</p>

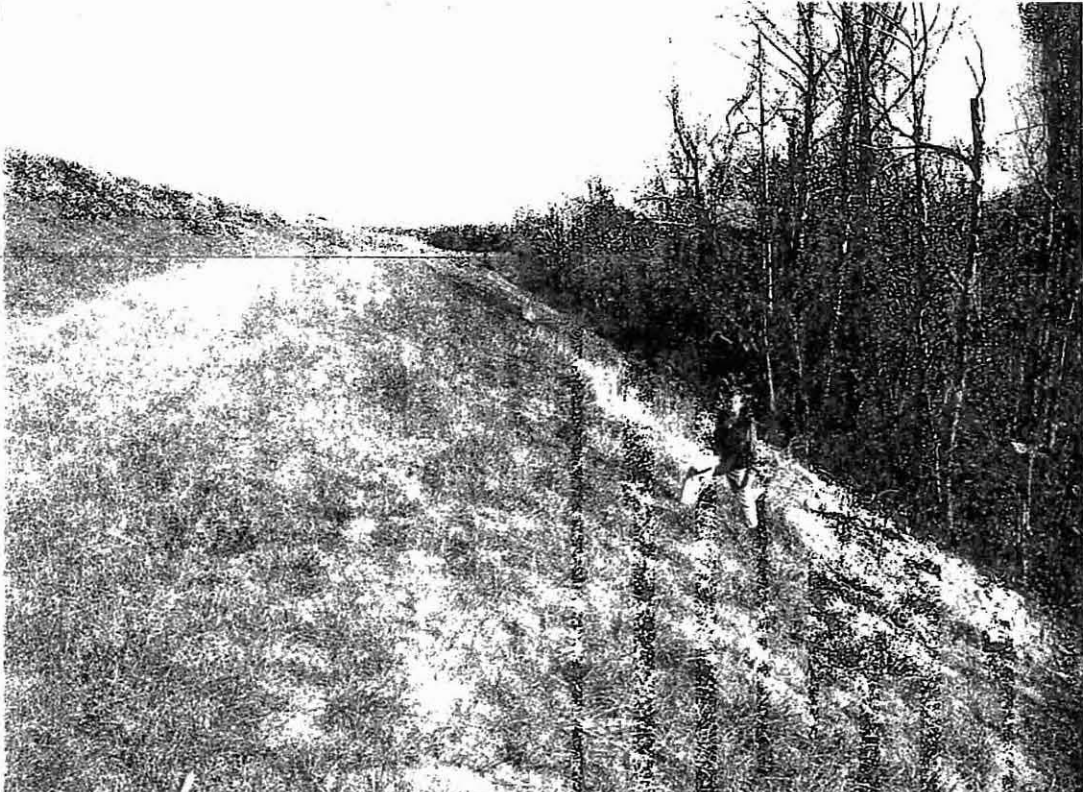
<p data-bbox="1263 233 1471 268"><b>Photograph 19B</b></p> <p data-bbox="1263 302 1528 436">Slump in slope below elevation 525 berm looking N-NE. Slump has moved since 2001.</p>
	Remarks

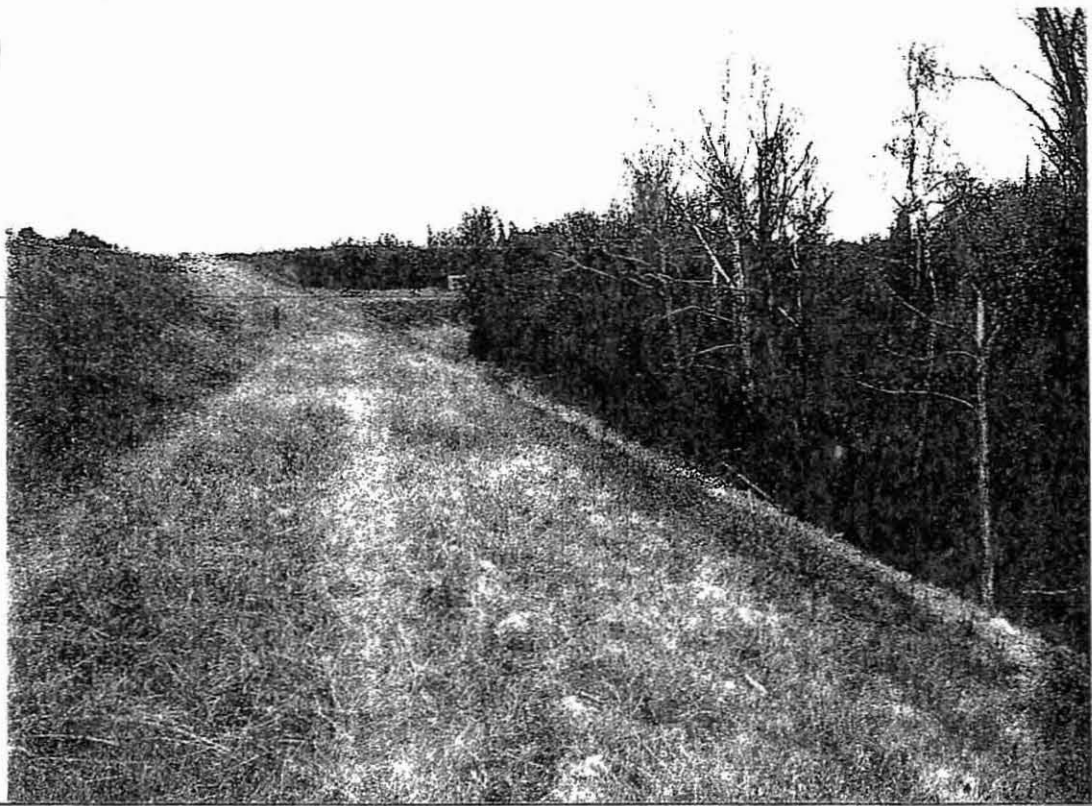
<p><b>Photograph 21</b></p> <p>Downstream slope of primary basin just before intersection with intermediate dike. Note vegetation has been removed from riprap since 2001. Significant seep halfway between berm and road. See test for additional significant features observed in this vicinity.</p>
	Remarks

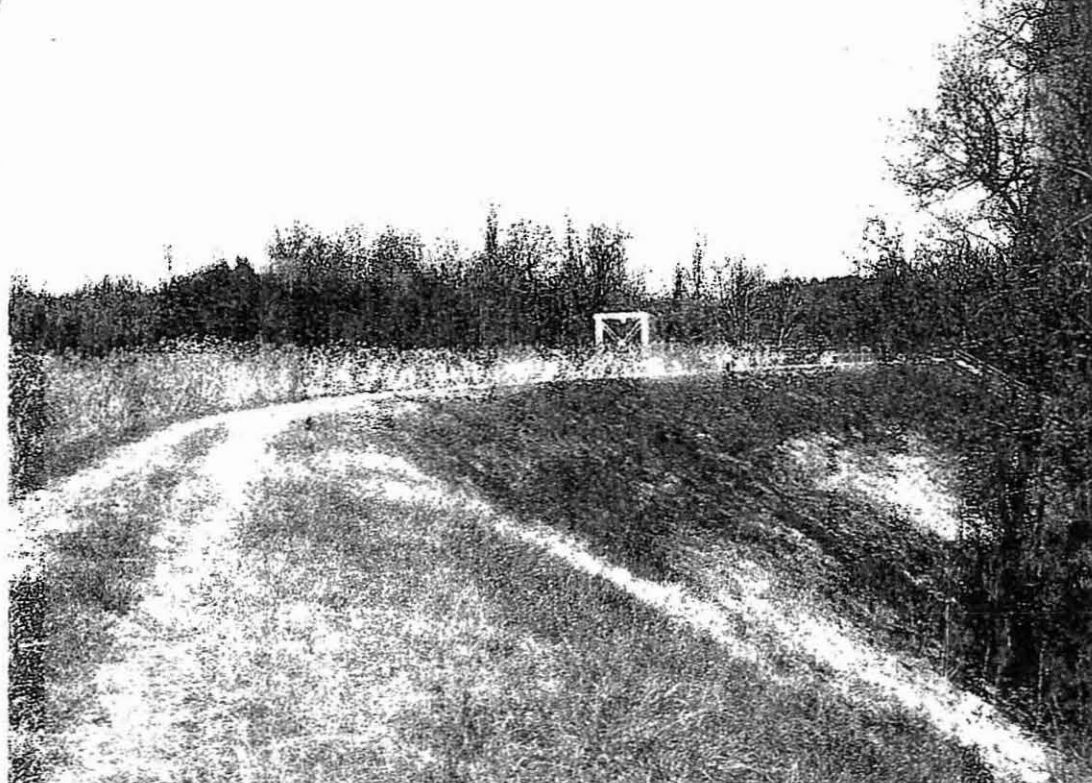
<p><b>Photograph 22</b></p> <p>Downstream side of secondary basin adjacent to Dan River. Note vegetation established in rip rap in 2001 has been removed. Some burrowing activity observed along top of riprap.</p>

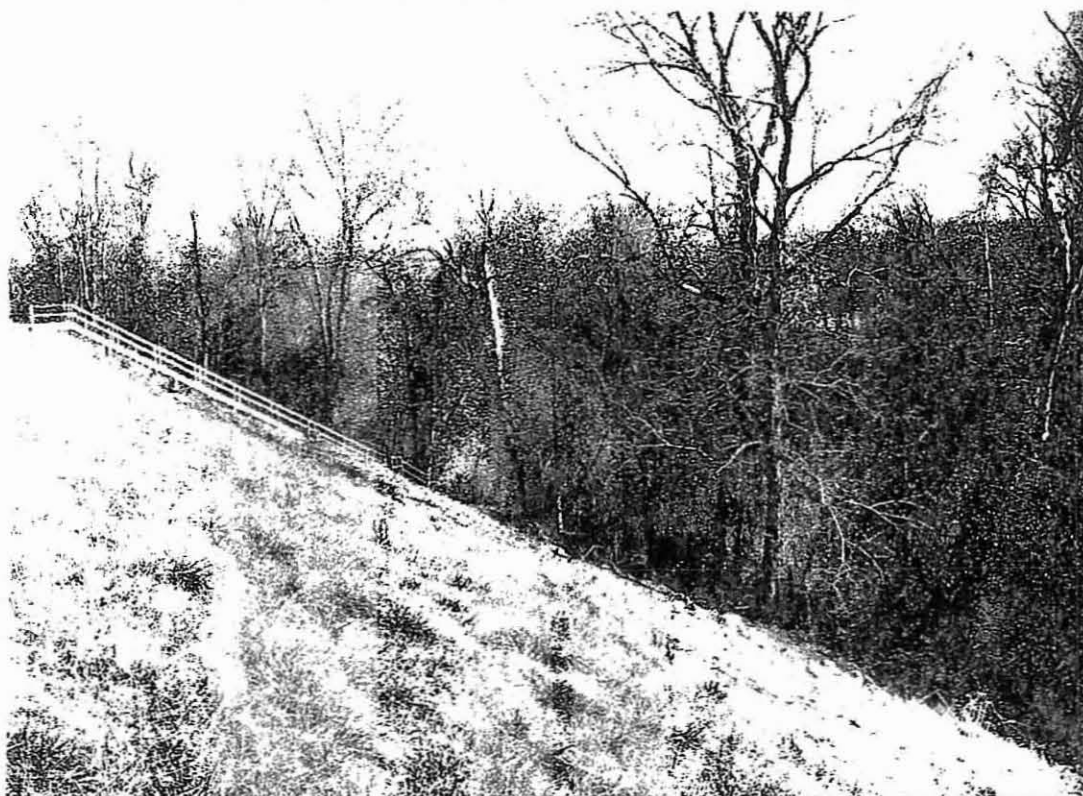
Photograph 23A

Riverbank is steep (active) and located nominally 10 ft from toe of dike in this vicinity.

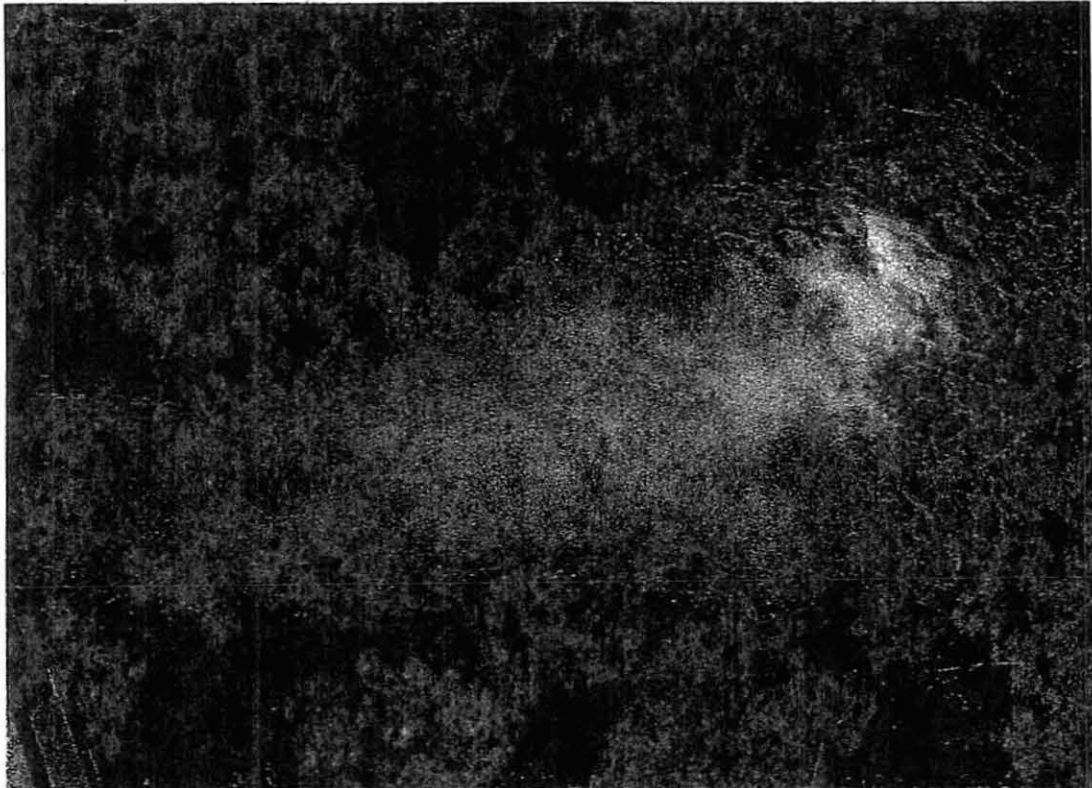
<p data-bbox="1290 1144 1483 1181"><b>Photograph 27</b></p> <p data-bbox="1290 1208 1579 1442">Discharge path to Dan River. Straight edge on concrete (1996) now somewhat eroded, but apparently no significant change since 2001.</p>
